Ageing performance of electromagnetic relays

evaluation based on a 13 years in-service study
and life testing

Helge Palmén, 18th of October, 2012

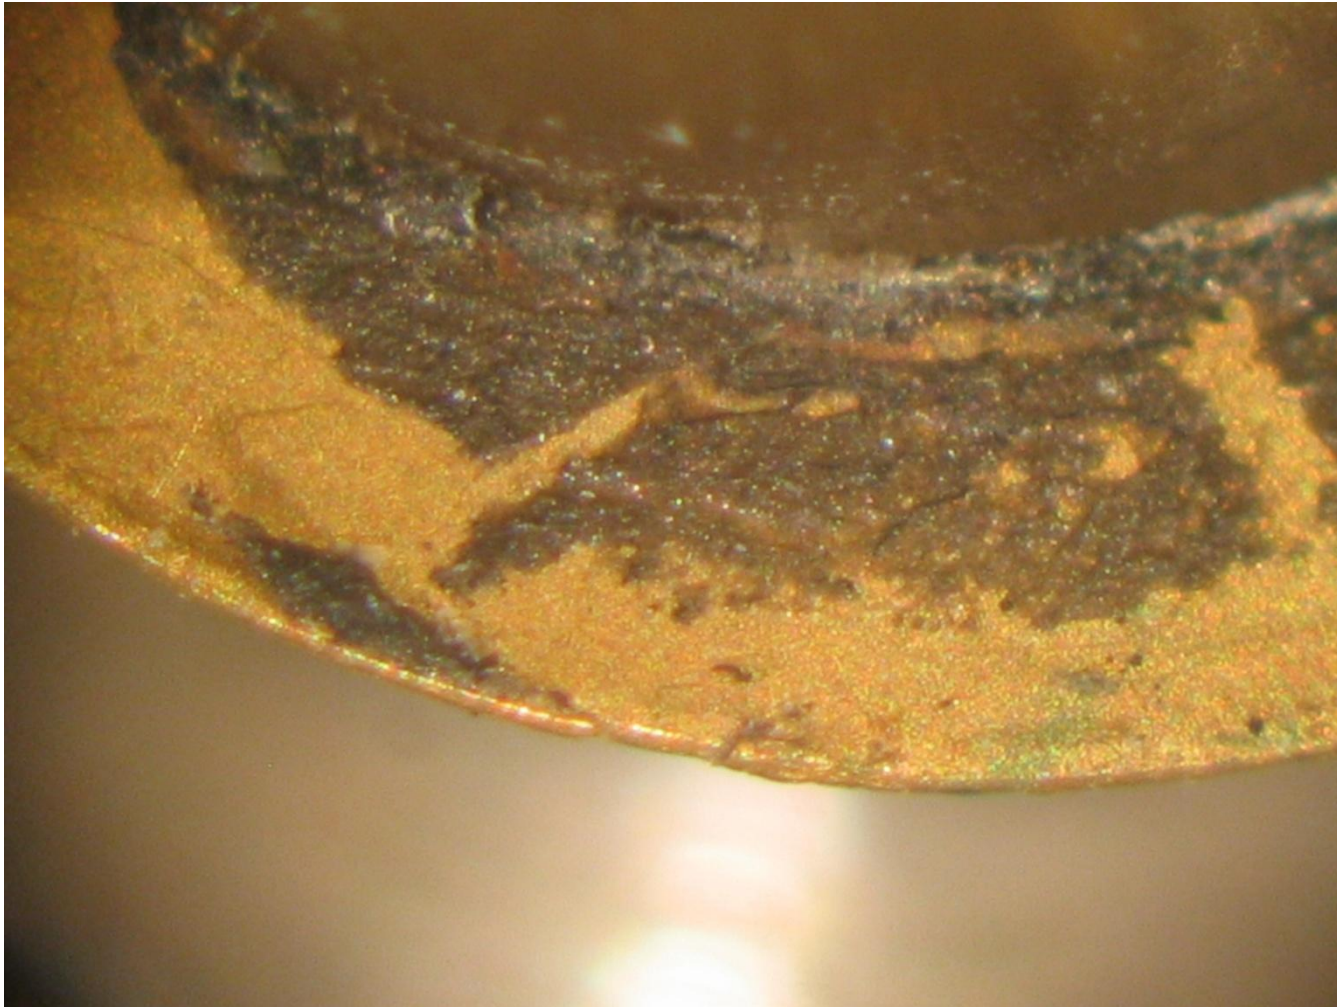
Corrosion products and other impurities on the contact surface (after 25 years of operation)

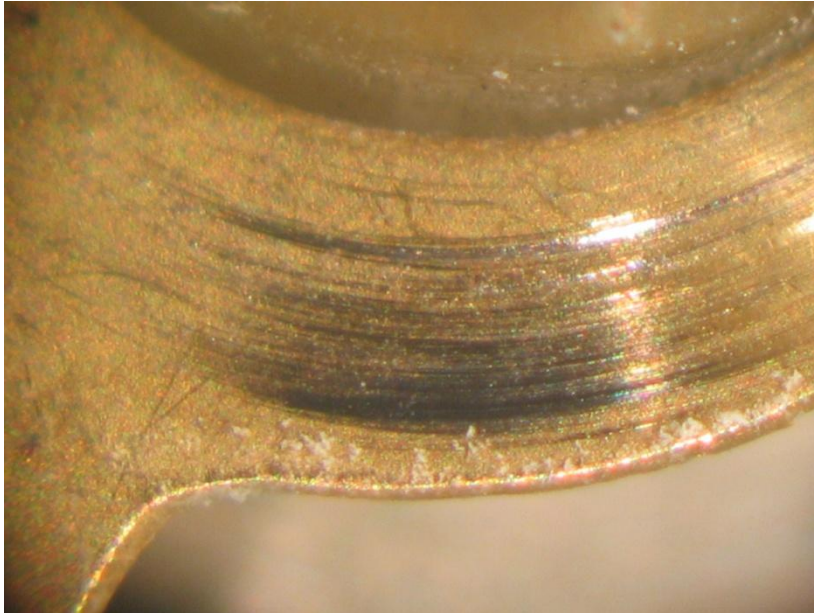
Wear of contact surface – on the right: light areas gold, grey areas nickel and dark areas copper

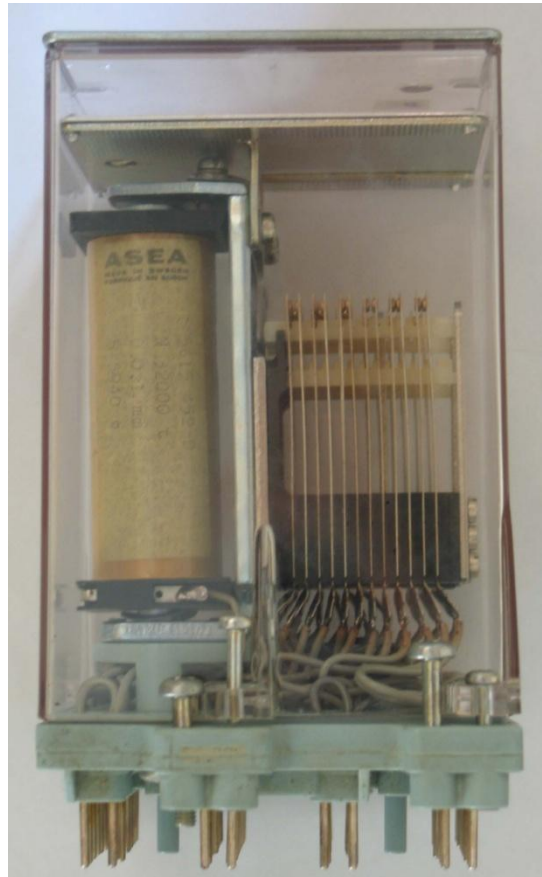
10 cm

Example of the relays, RXMA 2 RK211 189-AN:

- 110 V
- 10 NO and 5 NC contacts
- 5 A
- Environment:
 - $T_A = 20\text{ }^\circ\text{C}$, RH = 50 %
 - inside cabinet: $40\text{ }^\circ\text{C}$, RH \rightarrow 20 %

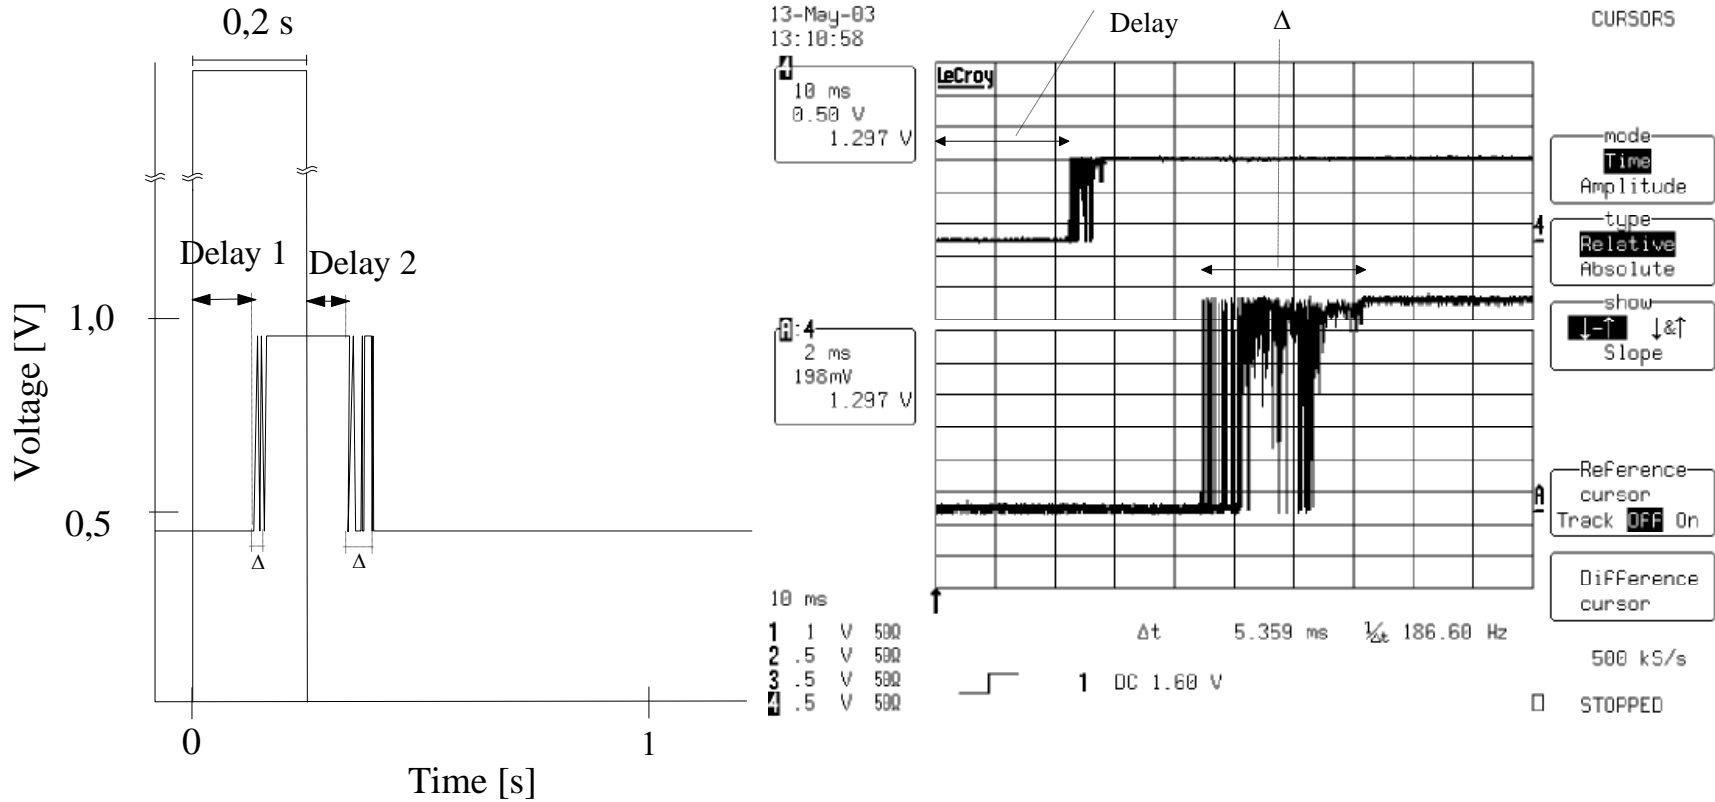
Figure 2. Output waveform

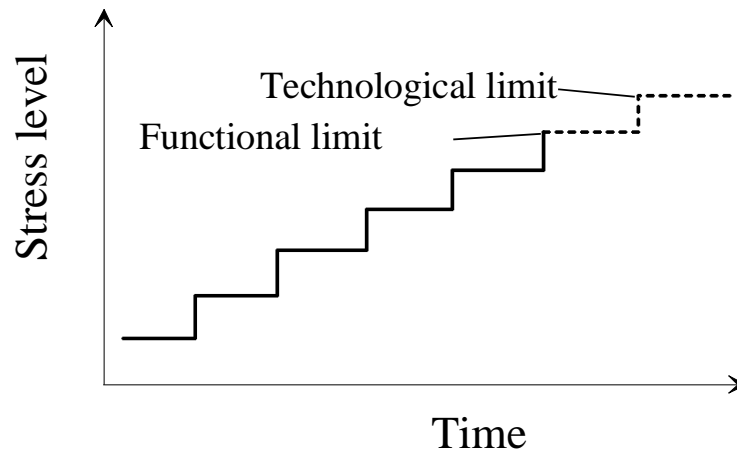
Figure Principle of step-stress testing

The test is continued until enough margin has been reached, all fail or irrelevant failures start to appear

Following steps were used: **55 °C for 168 h, 70 °C for 168 h, 100 °C for 242 h, 115 °C for 160 h, 130 °C for 169 h and 140 °C for 169 h.**

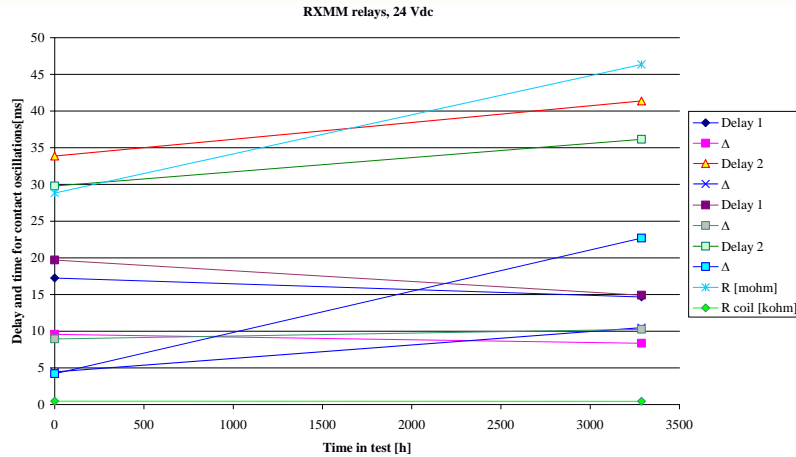
Figure 8. Average values of five 24 Vdc RXMM type relays (including mostly normally open and normally closed contacts). Test temperature 95 – 100 °C, four of the relays energised.

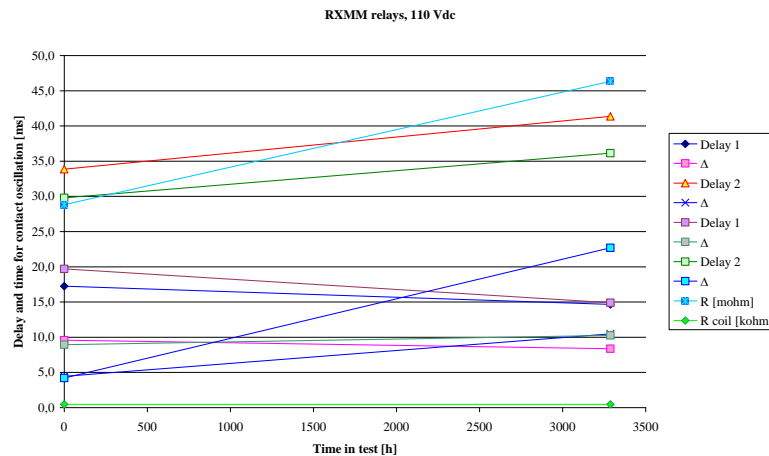
Figure 9. Average values of three 110 Vdc RXMM type relays (normally open contacts). Test temperature about 125 °C, relays energised.

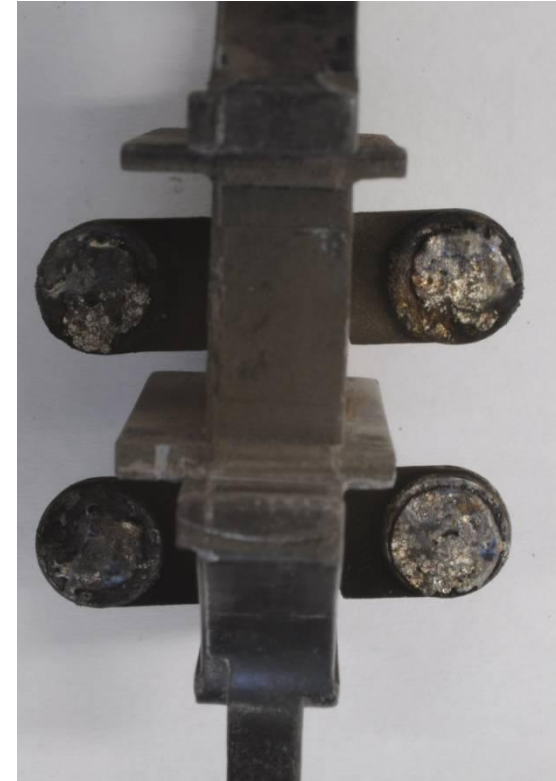
After about 3 years (note:
one contact broken off due
to melting of support piece)

- the contact material is silver cadmium oxide
